(10) **Patent No.:** **US 11,870,310 B2**

(54) **METHOD OF REPAIRING A HYDROGENERATOR**

(71) Applicant: **Electromechanical Engineering Associates, Inc.**, Monroeville, PA (US)

(57) **ABSTRACT**

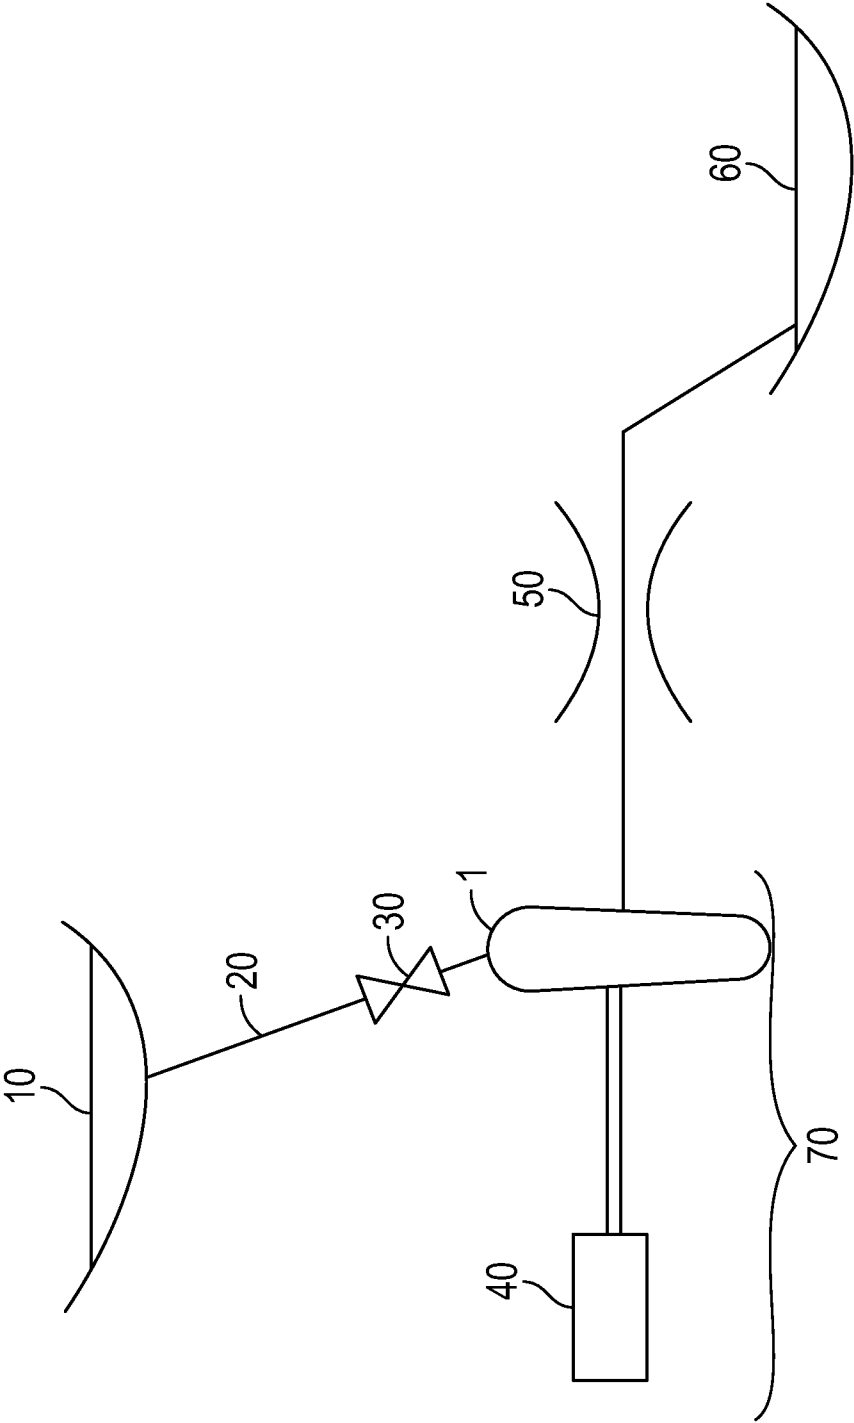
FIG. 1  
(Prior Art)

FIG. 1 illustrates a hydropower plant that includes an upper body of water **10** feeding a turbine **1** through a pressure line **20** via a shutoff element **30**. The turbine **1** drives a generator **40** that generates electricity. The turbine **1** and the electric generator **40** together form a hydrogenerator (hydroelectric generator) **70**.

FIG. 1 shows a possible hydropower plant;  
 FIG. 2 is a diagram of how a hydropower plant works;  
 FIGS. 3A, 3B, and 3C show a typical geometry and failure location of a rotor;

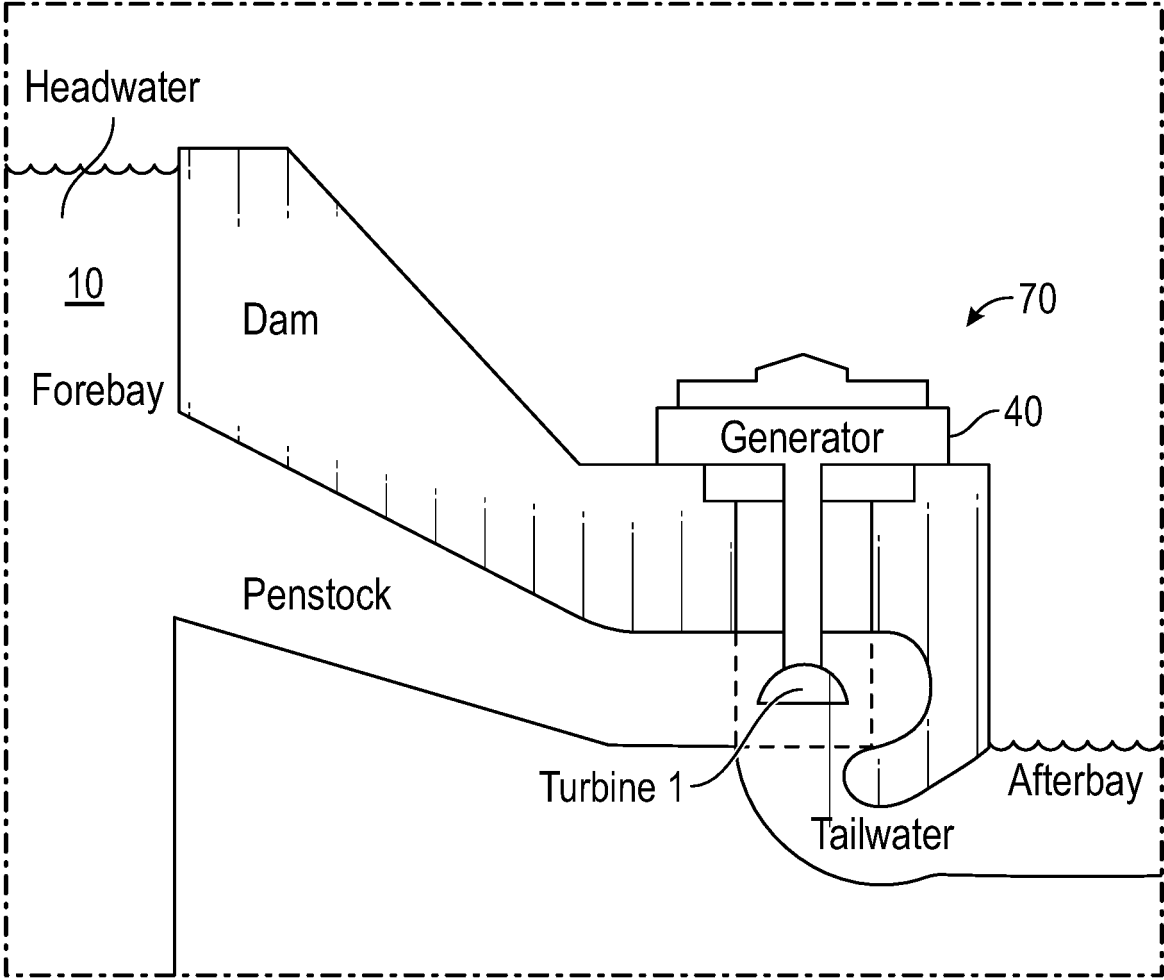
**FIG. 2**  
**(Prior Art)**

As shown in FIG. 2, a dam creates a reservoir forming the upper body of water **10**. The reservoir has a "head" or height from which water flows. A pipe (penstock) carries the water from the reservoir to the hydrogenerator **70**. The hydrogenerator **70** shown in FIG. 2 is a vertical hydrogenerator designed around a vertically mounted shaft assembly. Attached to the upper portion of the shaft assembly is a rotor **100** (see FIG. 3A) of the generator **40**. Attached to the lower end of the shaft is the turbine **1**. The turbine **1** has turbine blades driven by the fast-moving water from the penstock, something like a pinwheel in the wind. The turbine **1** drives the rotor **100** within a stator of the electric generator **70** to generate electricity.

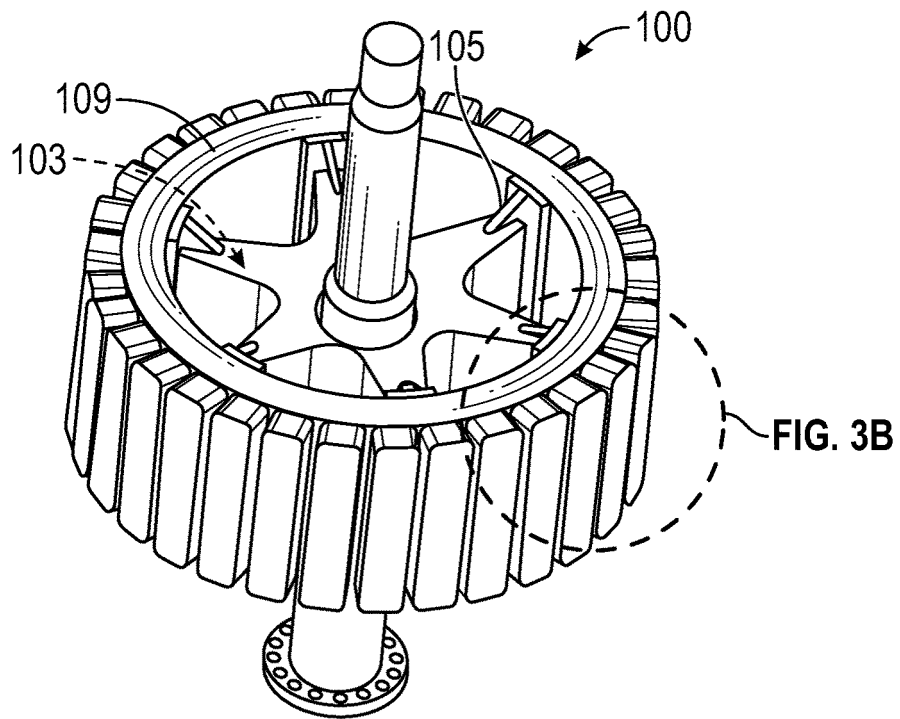
FIG. 3A  
(Prior Art)

FIG. 3A shows a rotor **100** of a typical electric generator **40**, and FIG. 3B shows a cross-section of the circled portion of the rotor **100** in FIG. 3A. The rotor **100** includes a shaft **102** and a spider **103** attached to the shaft **102**. The spider **103** supports a rim **108** surrounding the shaft **102**. The rim **108** carries a number of poles **110** spaced along the outer circumference of the rim **108**. When the poles **110** pass by poles in the stator during rotation of the rotor **100**, the electric generator **70** generates electricity.

The illustrated spider **103** is a welded steel structure having six spider arms **104** with vertical posts **105** at their ends that support the rim **108**. The rim **108** is a ring of laminated steel segments held together by solid steel end plates **109** at the top and bottom, and clamped together by bolts **130** (see FIG. 6) passing through the end plates and laminations. The rotor poles **110** in turn are supported by the rim **108** both radially, usually by dovetails, and axially by the rim **108**.

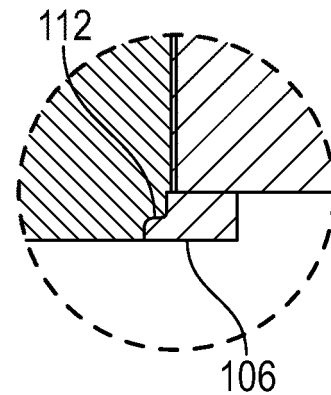
FIG. 3C  
(Prior Art)

vertical post **105** is provided with a rim support ledge **106** machined in the base of the vertical post. FIG. 3C shows a close-up view of a rim support ledge **106** machined in the base of the vertical post **105**. In general, the rim **108** is supported on the rim support ledges **106**, and is mounted on the spider arms **104** by a friction fit.

A common problem that occurs in the operation of the electric generator **40** is that wear occurs at the rim support ledge **106** generally due to friction between the rim **108** and the rim support ledge **106**. Because of different operational forces and other factors, the rim **108** may move with respect to the rim support ledge **106**, which can ultimately lead to damage, such as the fracture **112** of the rim support ledge **106** illustrated in FIG. 3C.

FIG. 6 shows a thrust plate assembly having a thrust plate **122** used in an embodiment of the disclosed method for repairing the electric generator **40** shown in FIGS. 3A and 3C as having a fractured rim support ledge **106**.

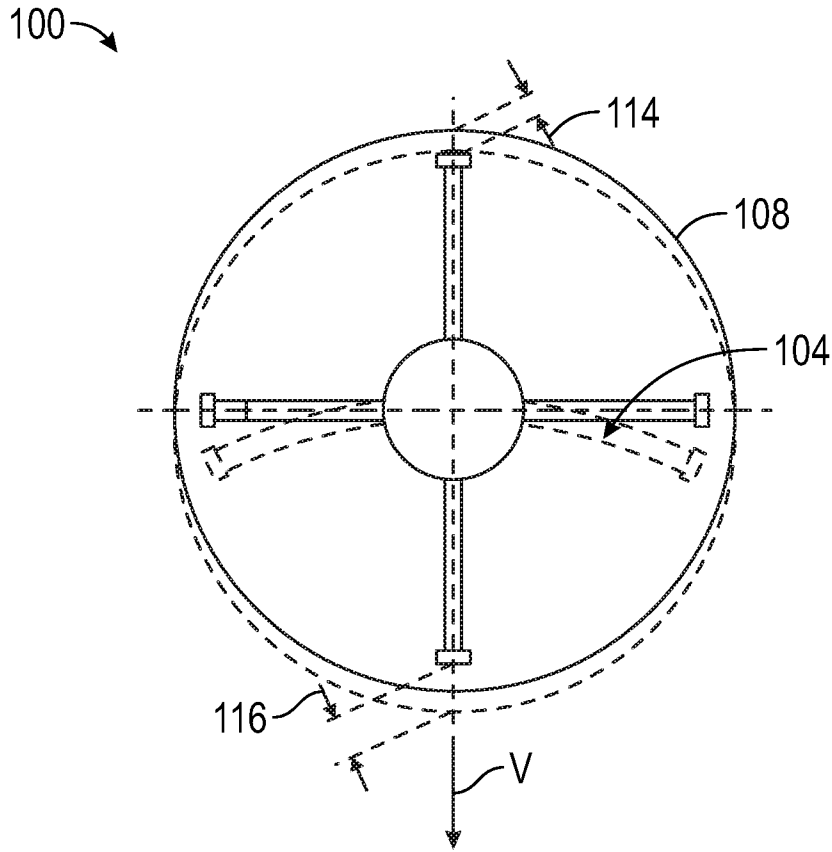
FIG. 4  
(Prior Art)

An unbalanced magnetic pole vector **V** on the rotor **100** is shown in FIG. 4. The clearance **114** at the top of FIG. 4 is shown as the clearance with the rim **108** concentric. The eccentricity **116** at the bottom of FIG. 4 is shown as clearance with the rim **108** eccentric. The magnetic forces distort the rim **108** during operation whereby, because of the rim's construction in layers, fretting or other wear occurs which ultimately leads to the failure of some part of the rotor structure which then must be repaired. The lateral flexibility of the spider arms **104** plus the loss of frictional interference between the rim **108** and the spider arms **104** permits the rim **108** to slide on the ledges **106** at each start, and also once per revolution, when exposed to an unbalanced magnetic pole. It is very difficult if not impossible to build a hydrogenerator which does not have an unbalance magnetic pole. Even the slightest unbalance will cause the components of the rotor to move with respect to one another and cause fretting if not other wear on the rotor.

FIG. 4 shows an unbalanced magnetic pole vector on a rotor;

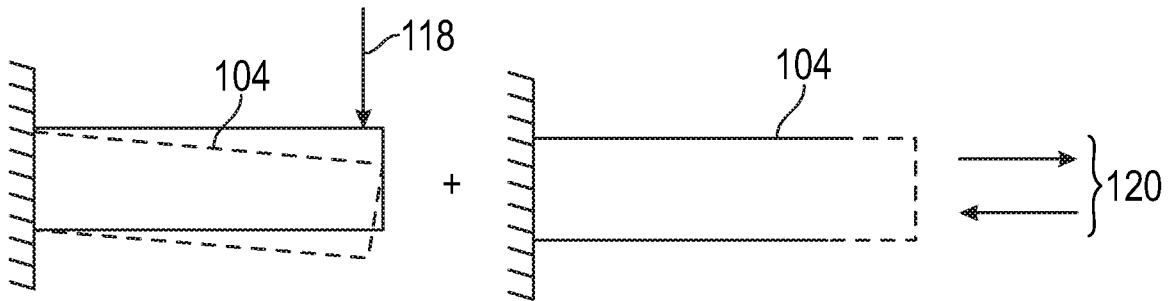
FIG. 5A  
(Prior Art)

FIG. 5A shows the force **118** of the dead weight of the rim **108** and the poles **110** pulling down on the spider arms **104**. FIG. 5B shows the traction (friction) force **120** from sliding, which forces combine to cause wear during operation. The dead weight of the rim **108** and the poles **110** will act upon components of the hydroelectric generator **70**. At each start and stop of the hydroelectric generator **70** there will be a centrifugal force on the generator rim **108**, thereby causing the components thereof to move with respect to one another. The movement of the components with respect to one another will cause or contribute in causing the fretting or other damage to the components of the rotor **100**, which will accelerate damage and the appearance of cracks in the structure of the rotor **100**.

FIG. 5A shows the dead weight of the rim and the poles of a rotor, and FIG. 5B shows the traction (friction) force from sliding.

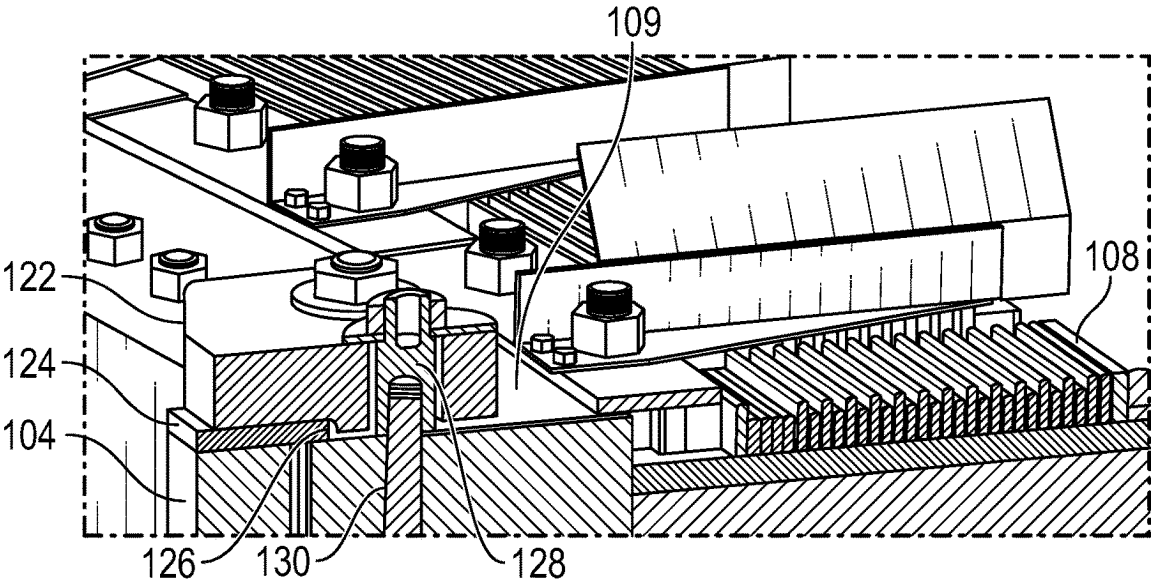
FIG. 6

In general, in this embodiment a plurality of thrust plates **122** are located one at each of a corresponding spider arm **104**. The thrust plates **122** support the rim **108** from above on the spider arms **104**. In other words, instead of the weight of the rim **108** resting solely on the rim support ledges **106**, which one or more rim support ledges **106** are cracked or completely broken off, the weight of the rim **108** is supported by the thrust plates **122**, such that the rim **108** is, in a sense, hanging from the thrust plates **122**. The thrust plate **122** is spaced apart from the rim **108** itself.

In the illustrated embodiment a wear plate or sacrificial plate **124** is located in a recessed or stepped or shoulder portion **126** of the thrust plate **122** between the thrust plate **122** and the spider arm **104**. A portion of the wear plate **124** may or may not extend so as to be in contact with the top of the rim **108**. The spacing of the thrust plate **122** a distance from the rim **108** prevents frictional contact between the thrust plate **122** and the rim **108**, and thus prevents wear. Instead, the wear plate **124**, which is lubricated with a solid lubricant, experiences friction and wear.

As the wear plate **124** wears down, a sleeve bolt **128** can be tightened periodically to tighten the connection of the thrust plate **122**. In this manner, the life of the rotor **100** can be extended without extensive repairs or replacement.

FIGS. 6 and 7 show an embodiment of a thrust plate assembly for a hydrogenerator in place on the rotor shown in FIG. 3; and

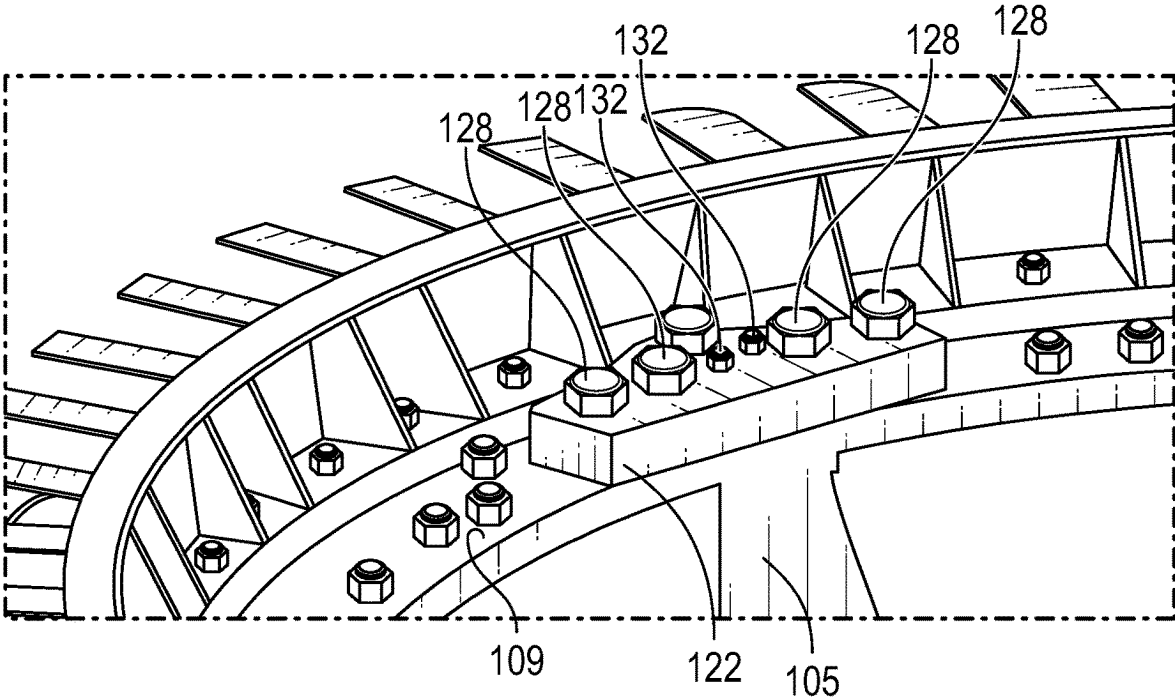
FIG. 7 illustrates mounting of a thrust plate **122** on the rim **108** adjacent to a spider arm vertical post **105**, and FIG. 8 illustrates the fasteners fastening the thrust plate **122** on the rim top plate **109**. The thrust plates **122** can be 3" (three inch) thick machined plates manufactured from ASTM A829 SAE **4140** with a minimum yield strength of 70 ksi, and a UTS not less than 118 ksi and a40% reduction in area. This provides strength while providing ductility and toughness for fatigue resistance. Each thrust plate **122** is affixed to the rim **108** with five sleeve bolts **128** that thread to the rim clamping studs **130** (see FIG. 6), and two 1.25" (one-and-one-quarter inch) alloy socket head cap screws **132**.

The sleeve bolts **128** are modeled for stress analysis as though a 2.75" (two- and three-quarters inch) Hex bolt with a suitable length of unthreaded shank were cut off, bored and tapped with 1.75"-5 UNC inside threads. The minimum tensile area of this configuration is slightly greater than that of the original stud. The sleeve bolts **128** are made from commercial Grade 5 bolts, and thus will be at least as strong as the rim studs **130**. The length below the heads will be 3" (three inches); then with the washers under the head, contact of the bottom of the shank with the rim top plate **109** will be avoided.

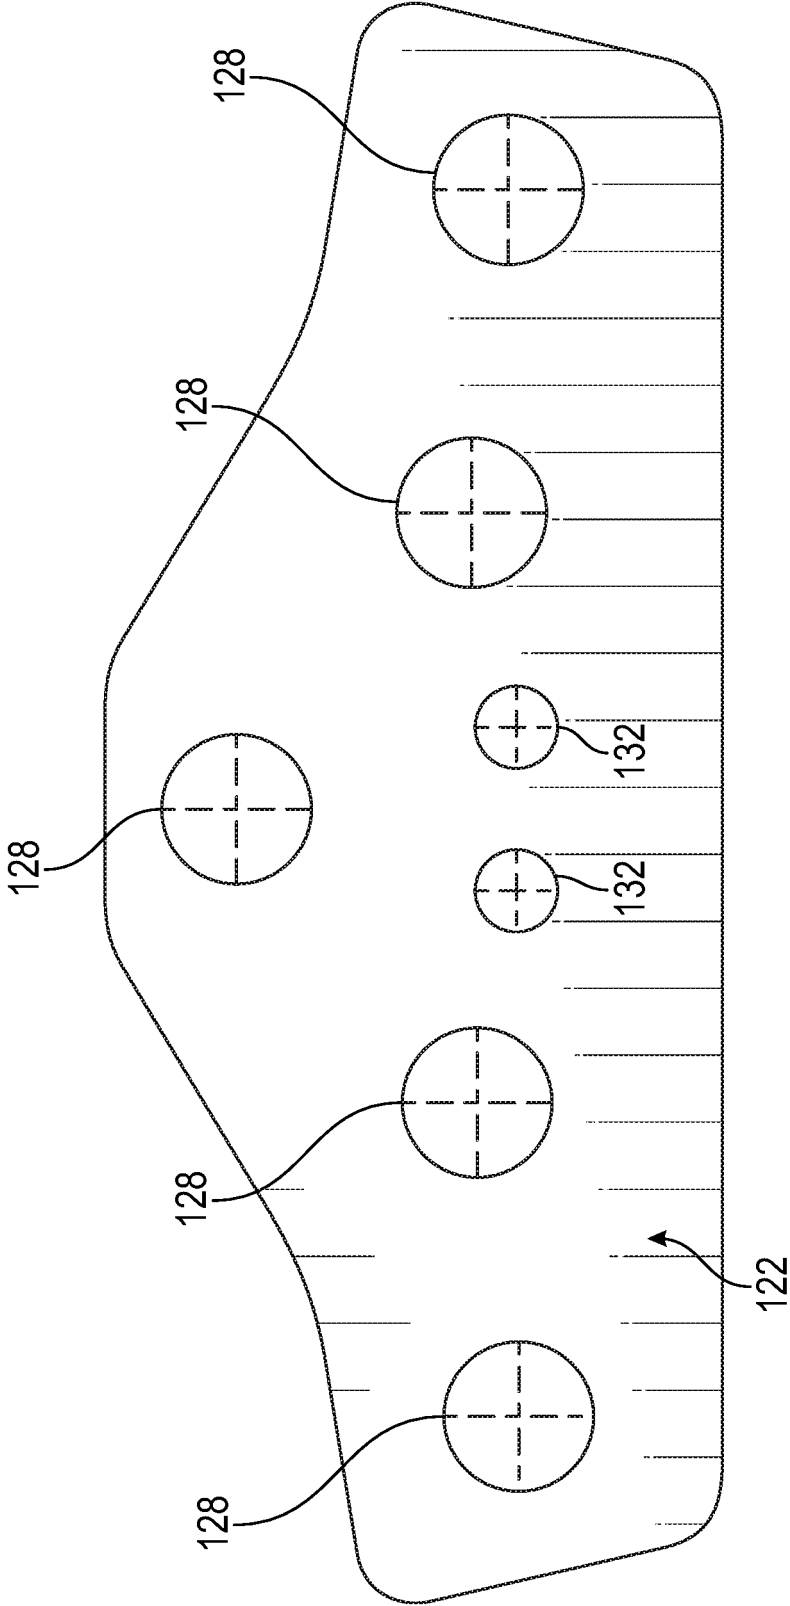
The two 1.25" (one-and-one-quarter inch) socket head cap screws **132** are used to resist localized bending due to the weight of the rim **108**. The design specification calls for a maximum of 1/3rd (one-third) of the rim weight to be carried by an individual thrust plate **122**. This is slightly over 33 tons for the illustrated rim, and though obviously could not be carried by all of the thrust plates **122**, could conceivably be carried by some of them. The rim top plate **109** must be drilled and tapped for the Helicoil thread insert corresponding to this thread.

FIG. 8 is a top view of the thrust plate of the thrust plate assembly shown in FIG. 7.
